Lower Tyers Road, Ngauranga  
Gorge, Wellington  
(Part NZAA R27/537)

Archaeological Monitoring Report  
Under HNZPT Authority 2015/925

Prepared For Heritage New Zealand Pouhere Taonga  
(on Behalf Of Wellington City Council & Water  
Wellington)

Prepared by  
**Victoria Grouden (M.A.)**  
March 2016

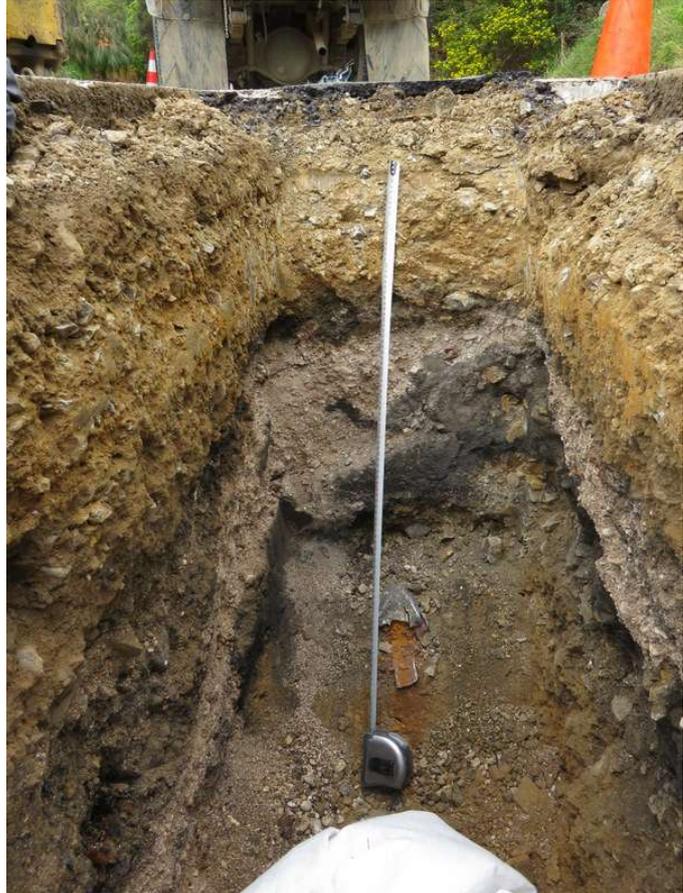
**Illustration 15: Point A Cross-Section facing west: Lower Tyers Road 18<sup>th</sup> September 2015 (scale 1m)**

Excavation work began in the area from Point A northwards as shown on Illustration 14. This area was excavated down by 1m and showed mixed soils over an existing iron water pipe (see Illustration 15). Soil layers consisted of a layer of asphalt [L1] (120mm) over hard fill [L2] (300-300mm thick) over dark, mixed fill layers of ashy, burnt soils [L3] and pumice-filled soils [L3a] (up to 300mm deep).

It appeared at this point that fill material had been put in place to bring the road up to the present level. This may have occurred at the time that a new road was surveyed out there in 1906 (refer to Illustration 10).

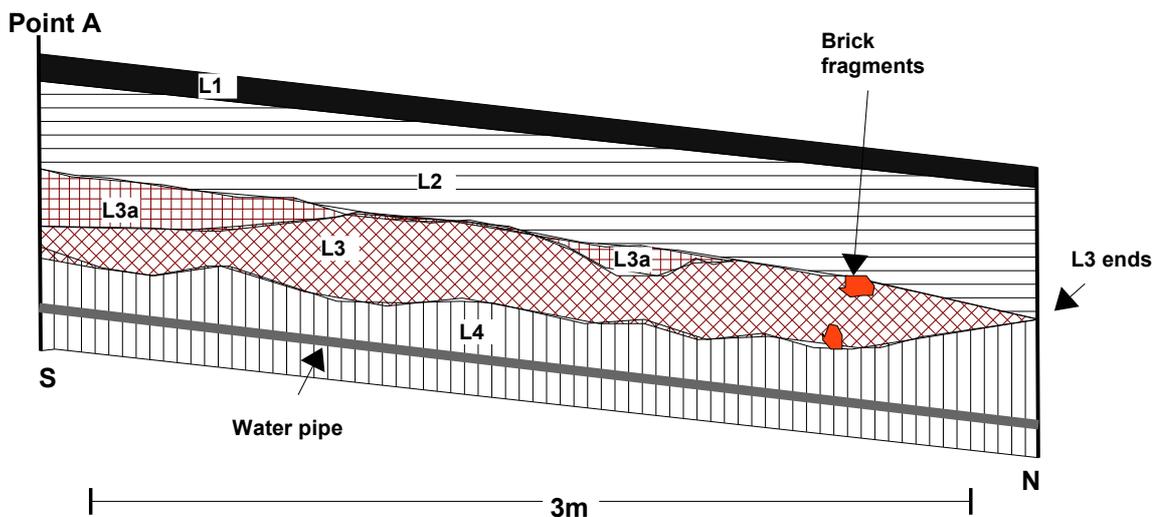
**Illustration 16: West baulk X-Section Point A (18<sup>th</sup> September 2015)**

It appeared that the southern end of Lower Tyers Road had been previously infilled by up to 1m deep for the majority of its extent. The hard fill observed in two layers within the Point A cross-section [L2 & L4] separated by a dark, ashy layer ([L3], had amalgamated into a single layer some 3.3m north of Point A and this trend continued throughout the remainder of Section 1 (see Illustration 14).

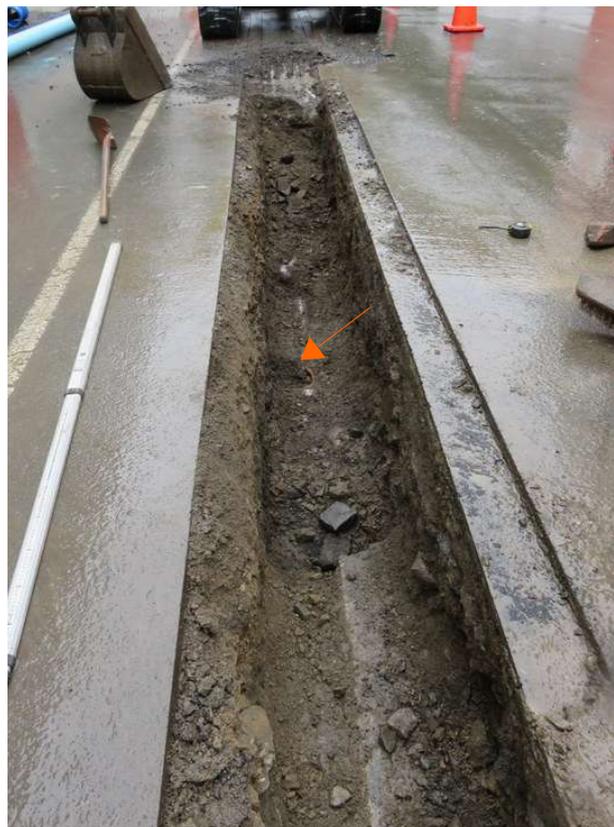
**Illustration 18: Red earthenware drain pipe at end of concrete slab: Point 21<sup>st</sup> September 2015)**

Further along the trench in Section 1 a piece of red earthenware drain pipe was exposed at Point F, Section 1, at the end of a concrete slab set some 800mm below road level (see Illustration 14, Illustration 18 and Illustration 19). The slab appeared to have been cast in place and measured 4400mm long and was 120-180mm deep. It is likely to be a building footing of some kind, although no buildings were shown in this location on the 1906 plan of the tannery (see Illustration 13). This footing may pre-date that image as it seems unlikely that a new building would have been constructed in the roadway after that time.

The red earthenware pipe present at this point was a junction of several pipes. This is likely to relate to the concrete slab present nearby. The pipes and concrete slab were covered by multiple layers of clean, hard fill.

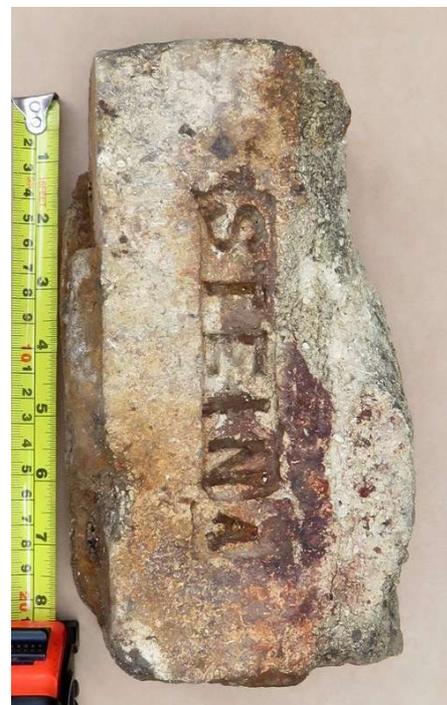
**Illustration 20: "Stein A" fire brick: Point G (21<sup>st</sup> September 2015)**

Stein produced a large variety of types of bricks primarily fire bricks such as that found at here. These were designed to withstand high temperatures and were generally used for fires, kilns and furnaces and often in industrial settings. It is not clear when this brick would have been manufactured but it looks to be later 19th-early 20<sup>th</sup> century by the quality of the manufacture and marking. It is likely that the “STEIN” would have been stamped separately to the “A” on the brick as these were added on an ad hoc basis depending on the type of brick being manufactured. The “A” may have been an indication of the brick containing alumina, a main constituent in fire bricks (Cranston, pers. com. 12, 03.2016).

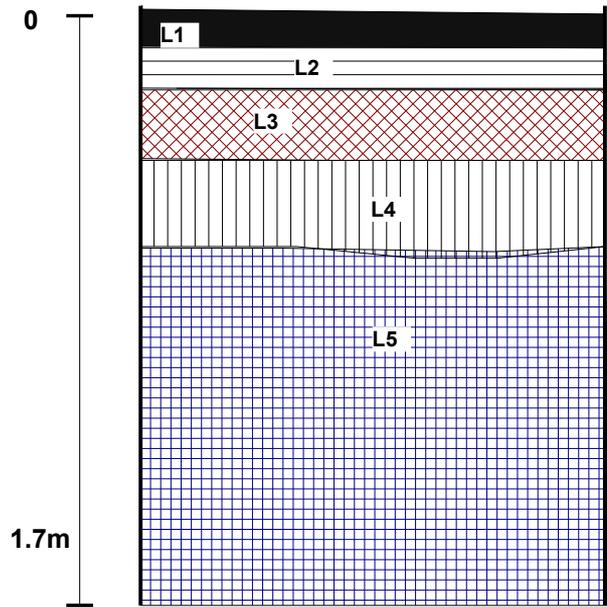
**Illustration 21: Point G: X-Section North-East Baulk: 21<sup>st</sup> September 2015**

At Point G a mixed fill was present in the trench to a depth of up to 1700mm (see Illustration 21). Layers included asphalt [L1] to a depth of 120mm overlying a thin layer of compacted rocky, yellow clay [L2] to a depth of 220mm. This overlaid a darker soil containing traces of fragmented brick [L3] to a depth of 420mm.

Other cultural material found at Point G included wire cut red bricks with one press moulded, red brick stamped “SSB...”. No further details have been ascertained about this brick so far. A mid green bottle base found in association was embossed L.T. underside the base and was most likely part of a beer bottle. A small amount of thin window glass, sheep bone fragments, copper wire, coal and charcoal was also found at this point. The material appeared to be general fill, rather than a specific rubbish pit, probably used to boost up the level of the road.

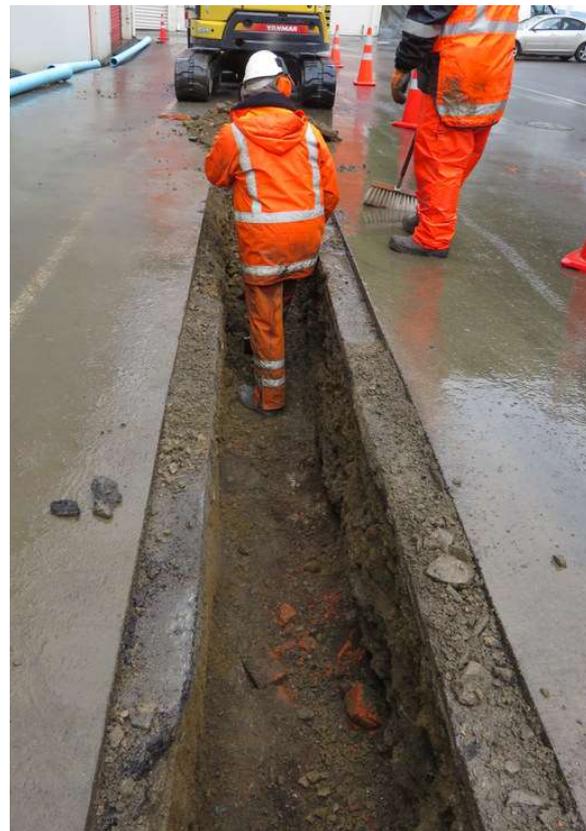
**Illustration 22: Brick concentration: Point H (18<sup>th</sup> September 2015-scale 500mm)**

At Point H (see Illustration 14), a second brick deposit was encountered. This material was present at a depth of 900mm and included whole bricks in loose association (see Illustration 23 and Illustration 22). These did not seem to have been formed into a path or foundation and were not mortared. Again they are

most likely to represent fill material. They were present for a distance of 1.7.-2m from Point H to the south-east.

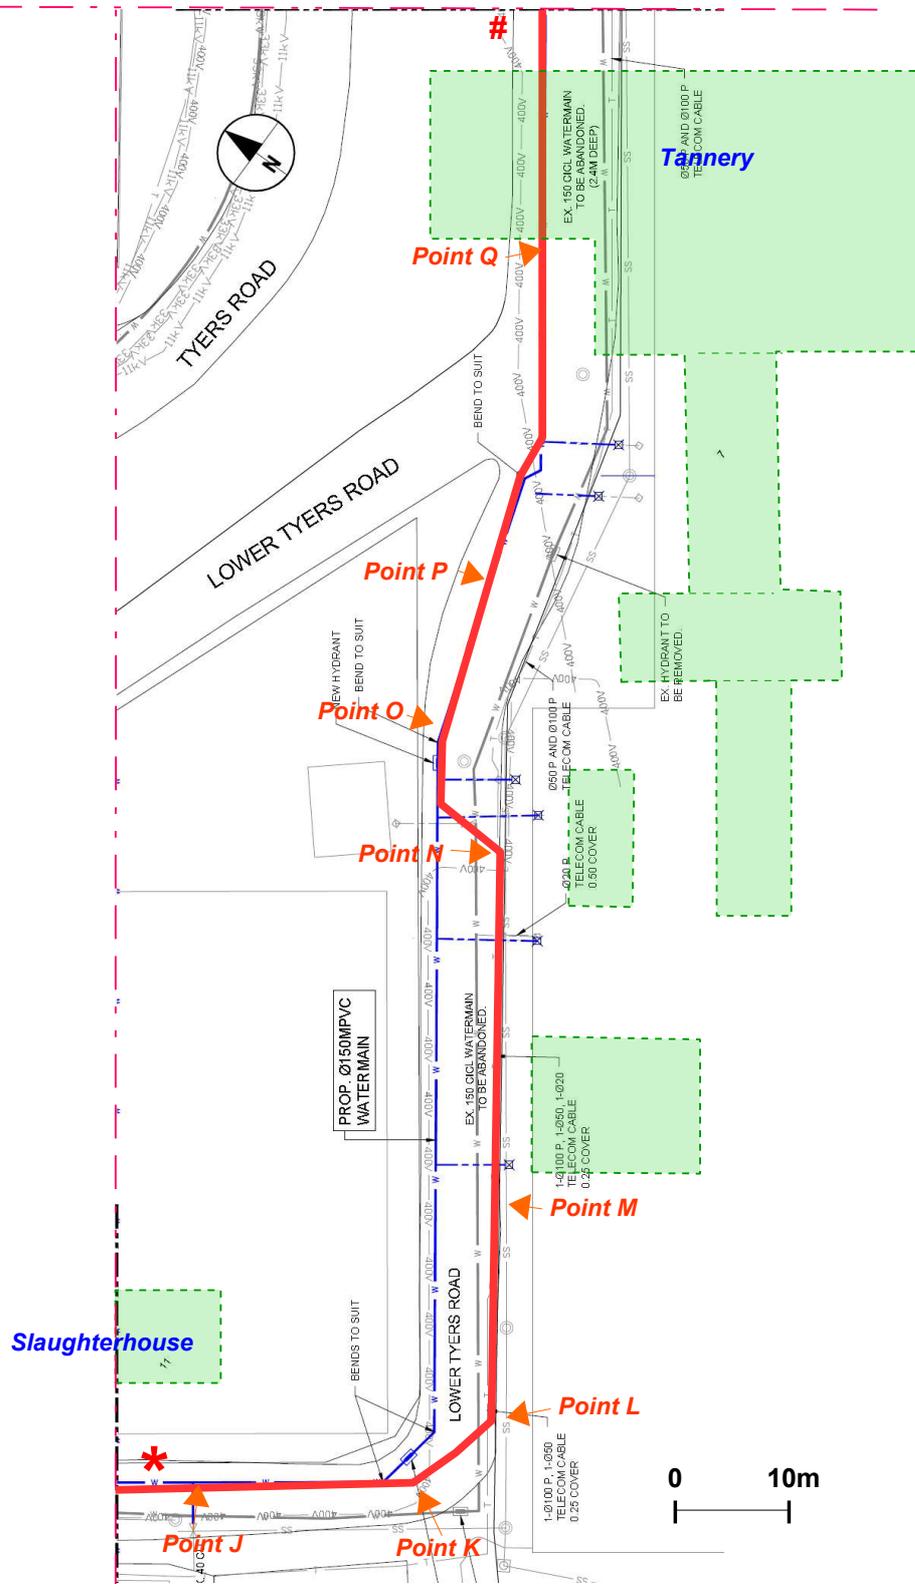
**Illustration 23: Section 2: Lower Tyers Road Water Main Renewal: Actual route of water main in red (base plan supplied by Aecom). 1906 Buildings indicated in green.**

Several glass aerated water bottles were found at a depth of 700mm below road surface at Point J (see Illustration 23). This included an A.G. (Alfred George) Saunders 10oz bottle with Codd type marble closure with two left tears and applied lip (see Illustration 24. The bottle was embossed “A.G. Saunders Trade [crossed key motif] Mark Wellington” on the face; “Cannington Shaw & Co Ld Makers St Helens England” on the lower back and “3264 A.G.S. 05” underside the base. Fisher dates an identical bottle to a 1907 manufacture (Fisher, 2003:167).

At Point L (see Illustration 23) a wide-bore, red earthenware stormwater pipe was noted running parallel with the new trench at 800mm below road level. The pipe was 250mm diameter and it continued within the side of the trench before turning and leaving it 20m further on at Point M (see Illustration 23).

At Point P (see Illustration 23) several layers of concrete slab were observed at a depth of 700mm-1m (see Illustration 31). At this point the asphalt [L1] overlaid a clay hard fill containing brick and stone fragments [L2].

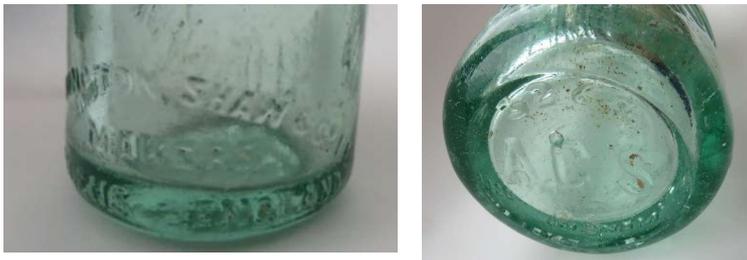
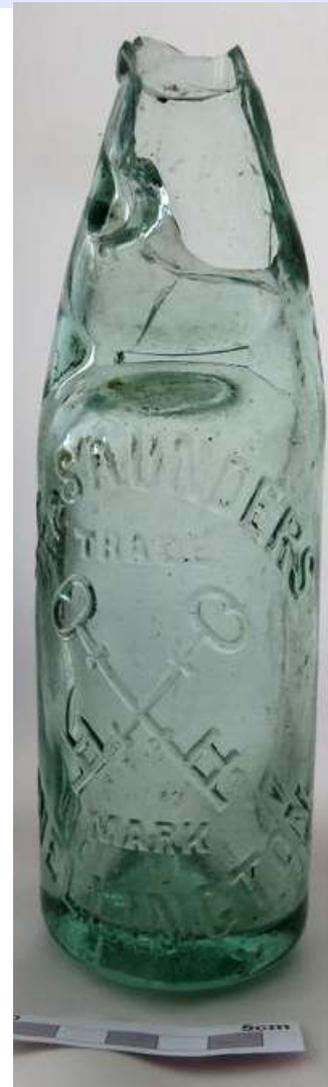
**Illustration 25: A.G. Saunders aerated water bottle: Point J. Base and back marks**

A.G. Saunders took over the large, Thorndon Quay business of C. W. G. Brodie in 1906 but was only in operation until 1909 when he sold to the Phoenix Aerated Water Company (Fisher, 2003:223). This certainly makes a narrow timeframe for the production of this bottle, and tends to suggest that material was deposited in the Tyers Road carriageway area to assist with forming the new road following the 1906 survey.

Dateable material found included a 1907 A.G. Saunders aerated water bottle (with Codd type marble closure) at a depth of around 700mm below surface. A late 19<sup>th</sup>-early 20<sup>th</sup> century Stein fire brick was also found in conjunction with other hand-made bricks at a depth of 700-900mm below surface in a different section of the trench. This corresponds with the fact that the road itself would have largely been formed after 1906, when it was first surveyed in to replace the informal track shown in Illustration 10. Cultural material was observed at the base of the 900mm-1m deep trench at many points along its length and one test excavation carried out at Point G indicated that fill material may be present in some areas to a depth of at least 1700mm. It seems that there will be significant remains at 1m and deeper within Lower Tyers Road, up to around 20m west of the Ngauranga Gorge Road intersection.

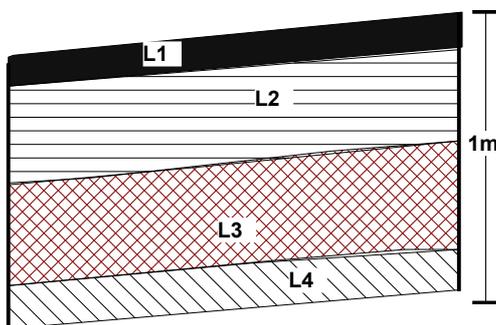
**Illustration 26: X-Section Point K: West baulk**

This overlaid a layer of darker hard fill with fragmented brick inclusions [L3]. This fill overlaid a clean, yellow clay material that may have been a natural soil layer, but may also have been another layer of clean fill [L4].

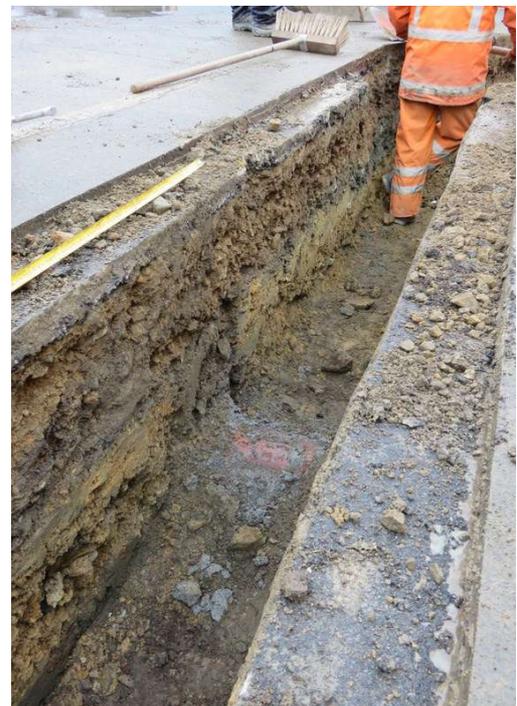
**Illustration 29: red earthenware drain pipe: Point O facing north-east**

containing larger stones [L4]. Fragments of fire brick were also found in this layer. A thin layer of gray clay was present beneath this [L5], overlying the lens of ashy sand with slag and brick fragments [L6]. The red earthenware drain pipe was present at this depth. Backfill above the drain pipe came from [L3] so it may be fairly modern.

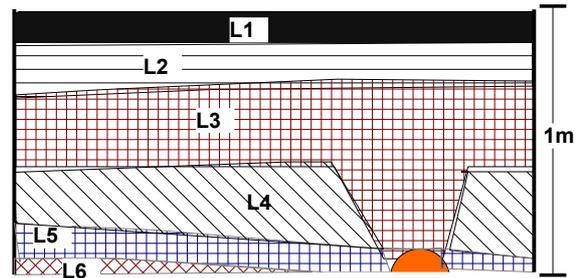
**Illustration 30: X-Section Point O: North-western baulk**

Beyond Point M, the new trench continued uninterrupted until reaching Point O, having crossed back over to the north-western side of the carriageway at Point N (see Illustration 23). At Point O at the base of the trench (950mm) there was a lens of mixed, brown-red sand (iron sand?) mixed with pieces of slag and broken, wire-cut red brick [L6] (see Illustration 29 and Illustration 30). A red earthenware drain pipe was present at the base of the trench (1m deep). Soil layers in this area were a little more complex than in other parts of the trench. The asphalt topper [L1] covered a layer of clean, hard fill [L2]. This overlaid a greyer coloured fill with small brick and stone inclusions [L3]. Beneath this was a layer of yellow-grey fill

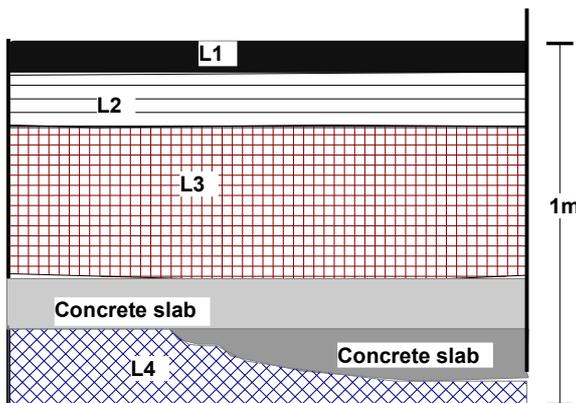
**Illustration 31: X-Section Point P: South-eastern baulk**

Beneath this fill was a mixed layer of apparent demolition rubble including broken concrete and brick fragments within a sandy, clay-loam [L3]. Two layers of concrete slab were present beneath this probable demolition material, overlying a layer of brown, loamy clay that may have contained organic material [L4]. This section of the trench showed a great deal of disturbance in general, and although no buildings are indicated directly in this position in the 1906 survey plan (see Illustration 23), it seems likely that there was some sort of structure here at one time, possibly predating 1906.

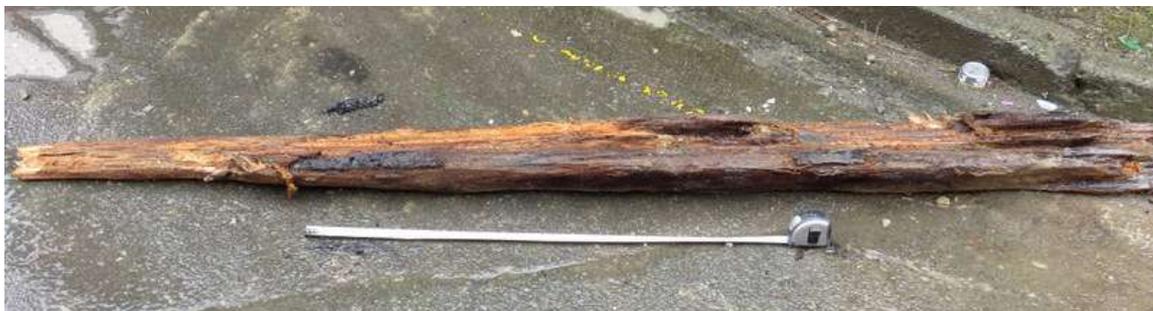
**Illustration 33: Point Q: Charred, dressed timber (23<sup>rd</sup> September 2015) (scale 1m)**

At Point Q a 2.5m length of dressed timber with evidence of charring was found at a depth of 900mm (see Illustration 33). This may relate to the demolition of the tannery buildings shown on Illustration 23, because part of the main structure was located close to Point Q.

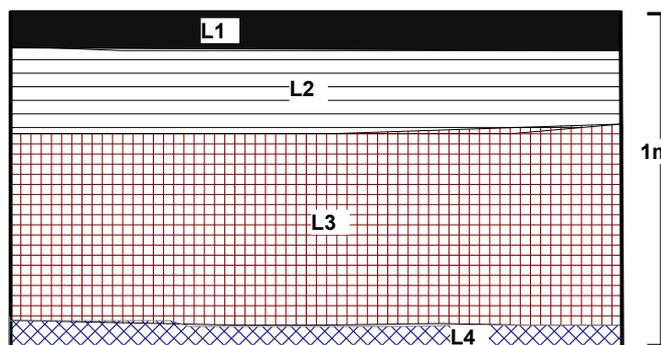
**Illustration 34: Generalised X-Section Point Q-Point R: North-western baulk**

Between Point Q (see Illustration 23) and Point R (see Illustration 39), there was a fairly uniform stratigraphy within the trench (see Illustration 34 and Illustration 35). This consisted of the asphalt topper [L1] overlying a 25mm deep dark, compacted clay fill with sparse crushed brick, slag and metal fragments [L2]. Beneath this layer was a fairly uniform fill of larger base coarse pieces with no cultural inclusions [L3]. At the base of this layer, some 800-900mm below road surface, there was an additional layer of dark fill containing wire-cut bricks (some mortared but likely not in original position) [L4].

It is not known how deep this additional layer [L4] of fill material is or at what level the natural substrate is located. However, there was certainly additional cultural material present there. Part of the slaughterhouse building was located across the route of the water main trench from approximately at the location of Point Q to 15m closer to Point R which was 60m north-west of Point Q. The bricks observed at the base of the trench were certainly more concentrated closer to Point Q, but there was no distinctive change in the trench stratigraphy to indicate the end of the building. There were also several cultural items found in the trench just north-east of Point Q, where the building would have been situated. This included a ferrous spring, and bolt and a ferrous barrel lid (see Illustration 36).

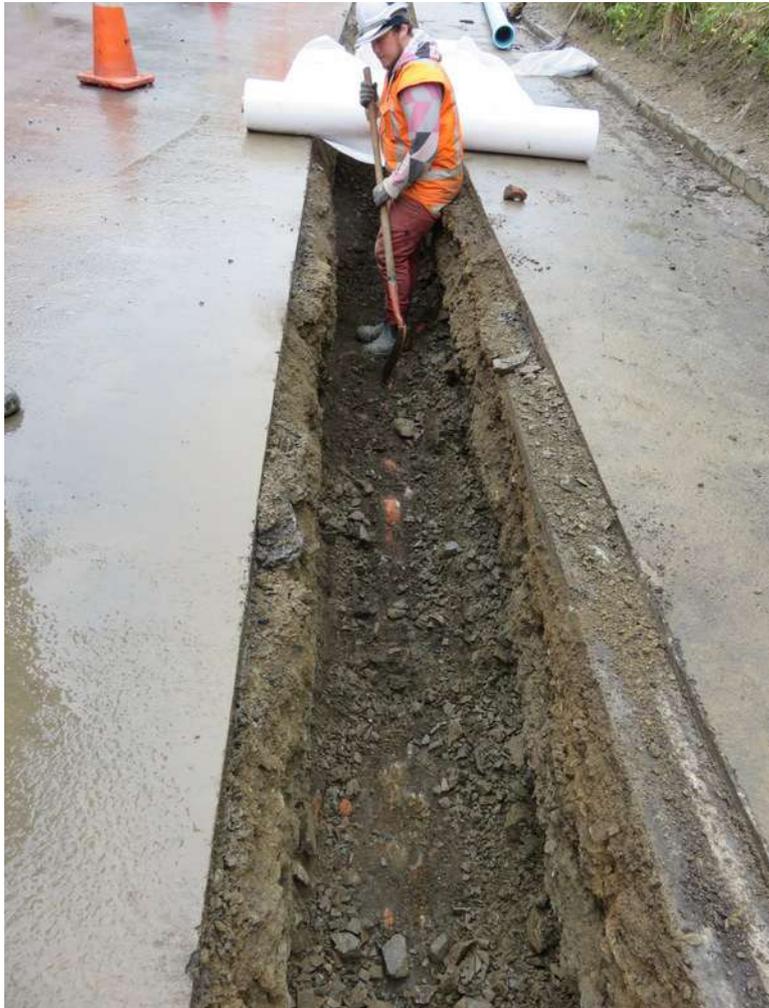
**Illustration 35: North-east of Point Q showing darker fill material with bricks [L4] at base of trench (800-900mm) (23<sup>rd</sup> September 2015) (scale 500mm)**

It is likely that the material observed at the base of the trench (at 900mm-1m below road level) is demolition material associated with the removal of this part of the slaughterhouse

and the formation of the new right-of-way (Lower Tyers Road) after 1906. Older deposits may well still be *in situ* below the level of the trench (greater than 1m below road level).

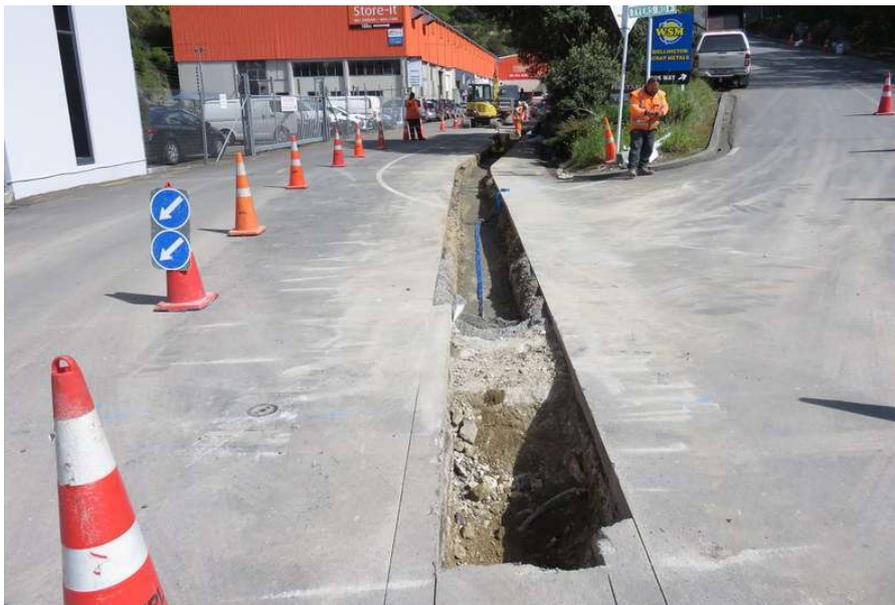
**Illustration 37: Facing south-west toward Point S (28<sup>th</sup> September 2015)**

From Point S, the trench dropped down to a depth of 1.6m as it reached the intersection with the Ngauranga Gorge Road (see Illustration 37 and Illustration 38.) All material in that section of the trench consisted of layers of base coarse, concrete and hard fill relating to the formation of the Motorway, the entrance to Tyers Road and the services underneath the road surface (such as the trunk water main). NO cultural material was seen there.
